# PROJECT PROFILE

## CARNWITH BRIDGE

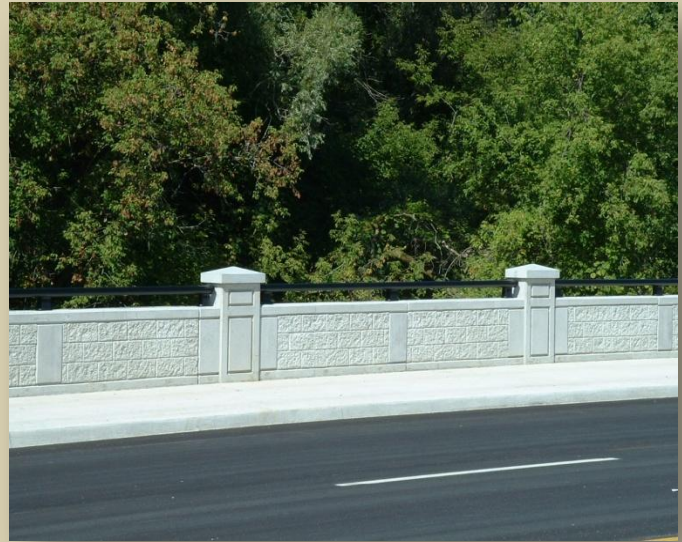
SRM Associates was retained to design a new road alignment for Carnwith Drive in the Village of Brooklin from Way Street easterly approximately 250m. The crossing of the curvilinear alignment over Lynde Creek required a 21.5m single span precast concrete box beam bridge with integral abutments. Environmentally, the bridge had to accommodate an endangered fish species; Redside Dace. Features such as vegetated buttresses, bioengineered slope protection and ensuring the abutments were well back of the streambanks, were employed in cooperation with staff of the Central Lake Ontario Conservation (CLOC). To improve the character of the area, with new housing developments nearby, a developer, in cooperation with the Client, funded improving the aesthetics of the concrete parapet walls. A combination of form liners, reglets, panels, columns, column caps and powder coated handrails were designed with striking results.
